CASE HISTORY

Stav Street Residential Building Restoration

Hod Hasharon, Israel

MCI®-2020 Gel

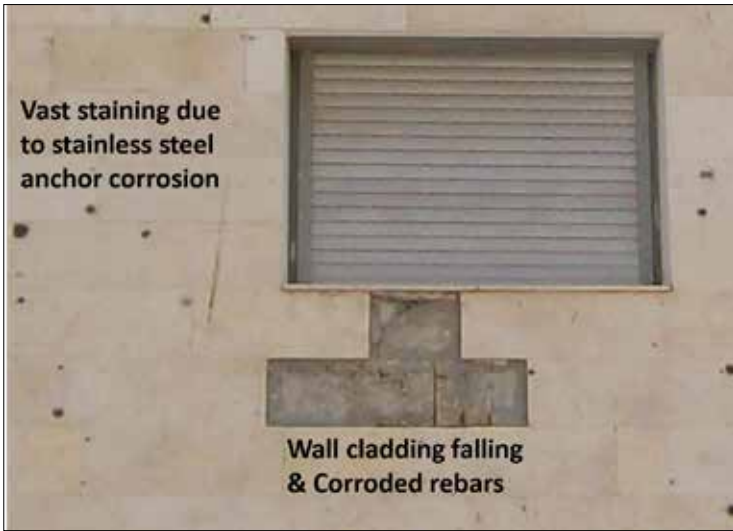
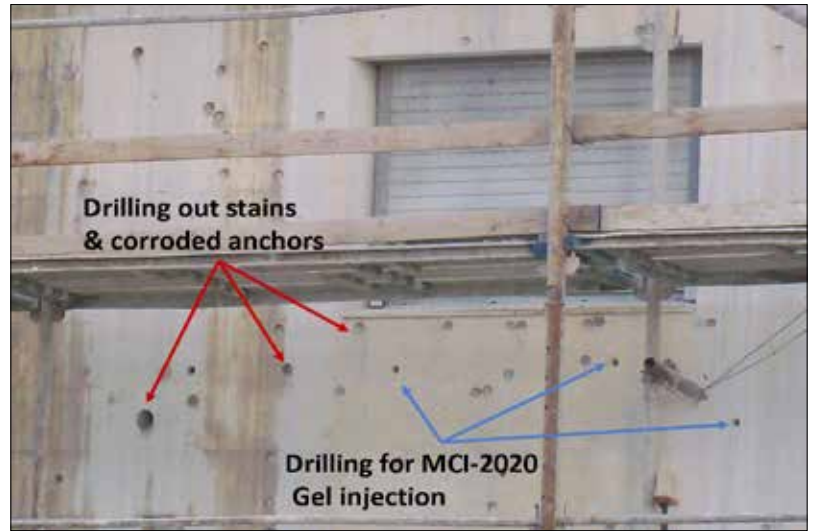
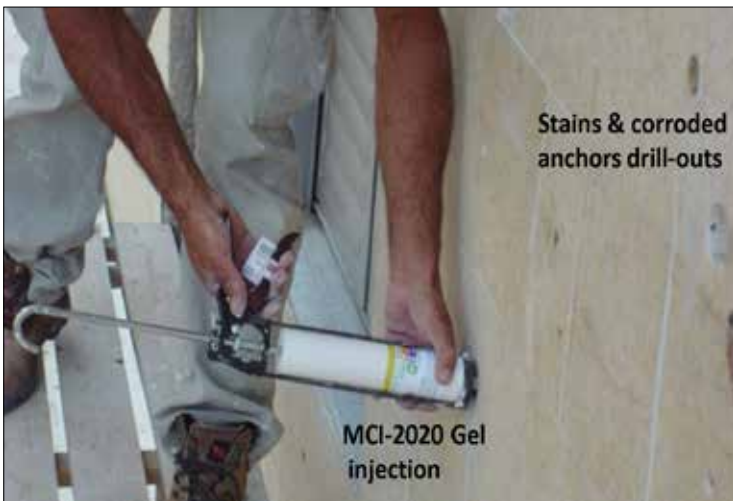
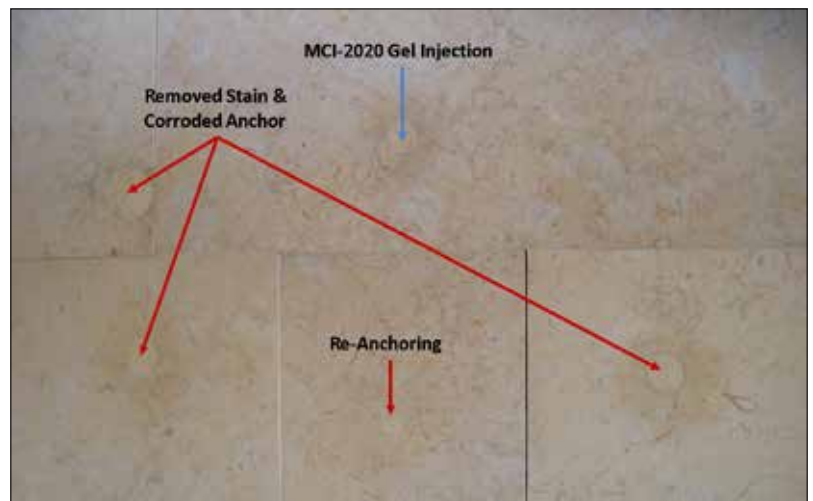
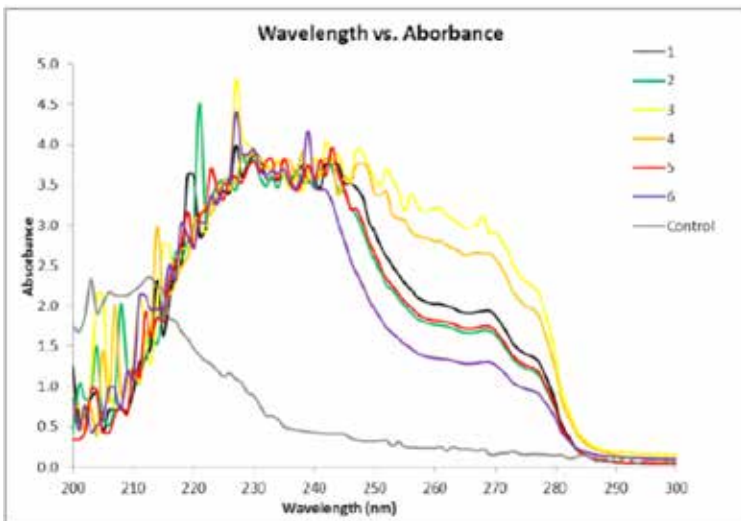
Problem: Stone cladding tiles began detaching and falling off a residential building only five years after its construction. The cause of the damage was diagnosed as corrosion of the building's concrete reinforcement and cladding anchors. After seven years of legal litigation (12 years from construction), it was ruled that restoration should include drilling and injection of MCI®-2020 Gel corrosion inhibitors.

The wobbling and cracked cladding tiles were removed first. MCI®-2020 Gel was injected into holes drilled through the cladding, and the holes were capped with cementitious mortar. All corroded anchors and stains were drilled out and filled with repair mortar. All tiles were re-anchored by new screws. To minimize the change in surface appearance, drilling locations were masked using caps prepared from the original cracked tiles.

The reconstruction project was deemed very successful. Six months after application, a test was performed that verified the presence of corrosion inhibitor throughout the concrete. Five years after application, a visual survey showed no appearance of new corrosion stains. The project was deemed very successful, and additional projects of a similar nature have since been completed in Israel.
