CASE HISTORY

Ship Shafts and Bearings Preservation

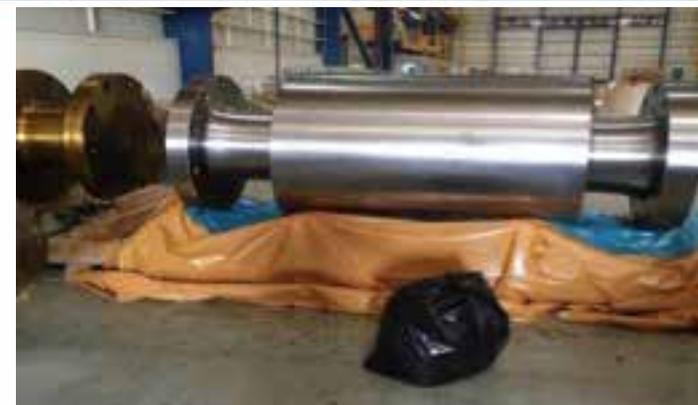
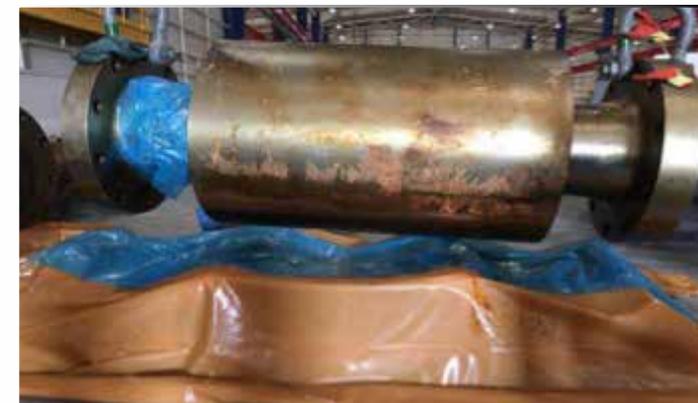
VpCI®-422 was used to remove rust and condition/clean the surfaces of the intermediate shaft bearing and dummy shafts. VpCI®-414 Cleaner/Degreaser was used in a 5% solution to ensure surfaces were free of dirt, dust, and oils. VpCI®-369 and VpCI®-368 were applied to all bearing components such as bolts and couplings for rust prevention. DesiCorr® VpCI® Pouches were placed in the internal cavities of all shaft assemblies to absorb humidity and inhibit corrosion. VpCI®-137 foam pads were used for all corners and edges prior to cutting MilCorr® VpCI® Shrink Film to size and wrapping the equipment. A heat gun was used to complete the packaging process.

The customer was very pleased with the cleaning and thorough packaging services provided. After three months the components were re-opened for inspection and evaluation, with no visible dirt or corrosion on the metal parts.
